RESA REPORT

**26247 North Paso Trail
Scottsdale, AZ 85255**

***Prepared by: Bret Hunting.
RESA Job #: 10902-5790 - OLSON
Inspection Date: February 27, 2009***

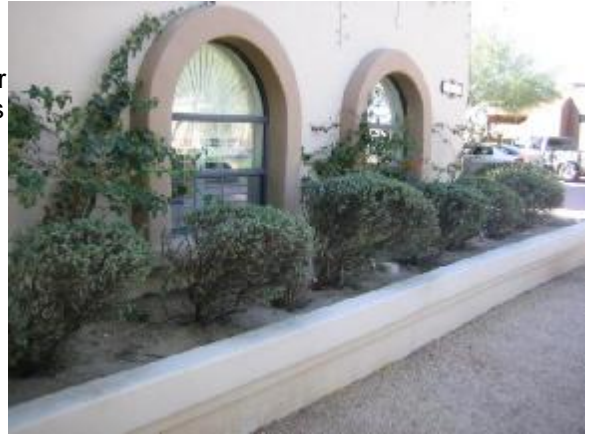
Slope

Elevation of soil at the exterior is higher than the floor elevation at the interior north garage wall. All areas tested dry, but the potential is present for rainwater leakage in the future. Monitor interior areas as a precaution or consult with a qualified landscaper for options.

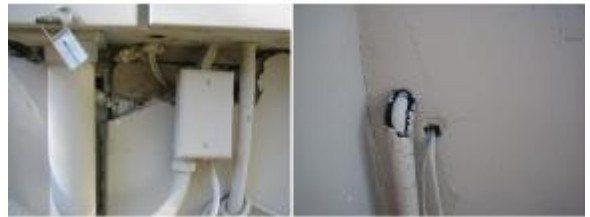
Penetrations:

Noted some large gaps in the stucco around the main electrical service panel, around the west a/c compressor lines and at each of the exterior hose faucet lines. Suggest having areas sealed to inhibit possible rain water incursion. No visible signs of mold like growth at this time.

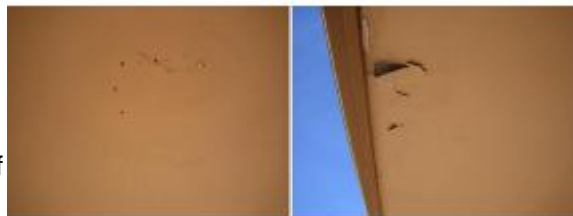
PORCH/PATIO CEILINGS:

Condition(s): Observed moderate water staining and water damage at the drywall on the rear patio ceiling, but no visible signs of mold like growth at this time. Suggest having roof checked and repaired if needed.

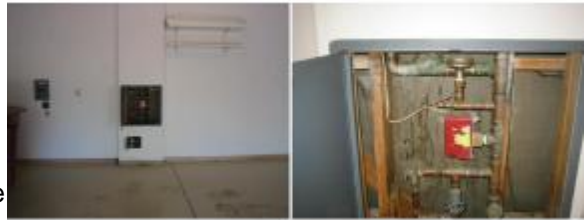
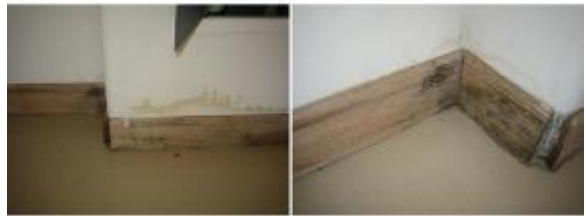
GARAGE:

Observed a few water stains at the garage ceiling, but no visible signs of mold like growth. Also observed water staining along the east garage wall below the fire sprinkler control box with some suspect mold like growth.

The visually effect area appears to be under 10 square feet in size. According to the New York City Guidelines, areas of surface mold under 10 square feet can likely be corrected by a general contractor following basic industry standards.

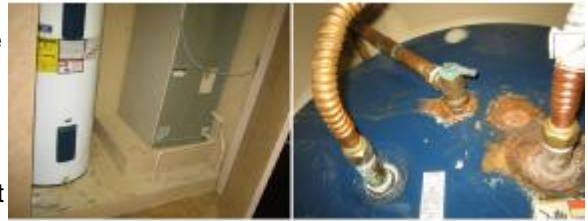
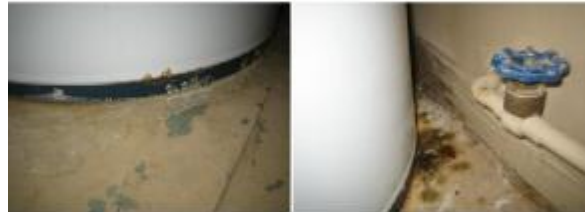
WATER HEATER

Observed signs of past leaks from unit and water damage and staining on the base boards around the unit. There is a small area of suspect mold like growth on the base board directly behind the water heater, but the visibly effected area appears to be under 10 square feet and could likely be corrected by a general contractor following basic industry standards.

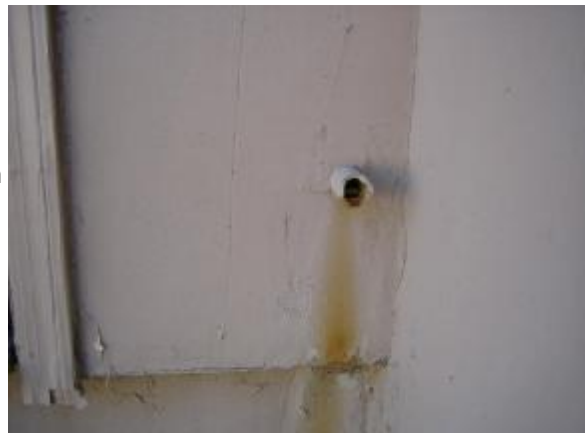
AIR HANDLER

I could not view below the units at this time based on their design, however, I did not observe any visible signs of leaks, water damage or mold like growth at this time. I did note that the condensate drain line at the exterior west wall of the home is broken and should be replaced.

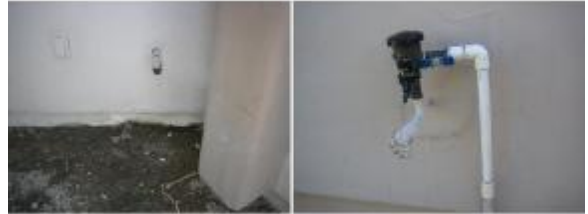
OTHER EXTERIOR FEATURES:

OTHER: The front hose faucet is dripping and I observed signs of past stucco repairs at the rear S/W hose faucet. No visible signs of mold like growth currently observed.

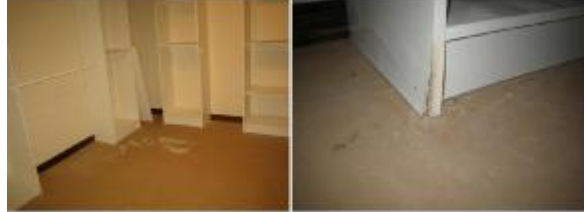
AREA: Upper N/W Bedroom and Basement Room.

FINDINGS: Observed water staining and water damage along the bottom of the cabinets in the basement room, but no visible signs of mold like growth at this time. No visible signs of water staining, water damage or mold like growth observed in the upper bedroom.

APPARENT CAUSE: Past leak/flood into the basement.

RECOMMENDATIONS: Recommend obtaining any/all records associated with the repairs and remediation conducted in the upper guest bedroom and basement for future reference.
